Camaro SS (LS3)

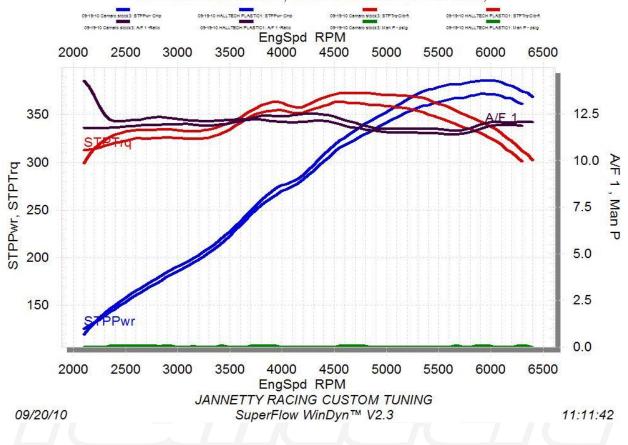
RPM/HP/TQ/AF1/ManP/AF2/Spd/ET/Cor

09-19-10 Camaro stock3, 09-19-10 HALLTECH PLASTIC1,

Corrected Data
